HIGHWAY/RAILROAD ACCIDENT REPORT

**Collision of Northeast Illinois Regional Commuter
Railroad Corporation (METRA) Train and
Transportation Joint Agreement School District 47/155
School Bus at Railroad/Highway Grade Crossing
in Fox River Grove, Illinois, on October 25, 1995**

NTSB/HAR-96/02 (PB96-916202)

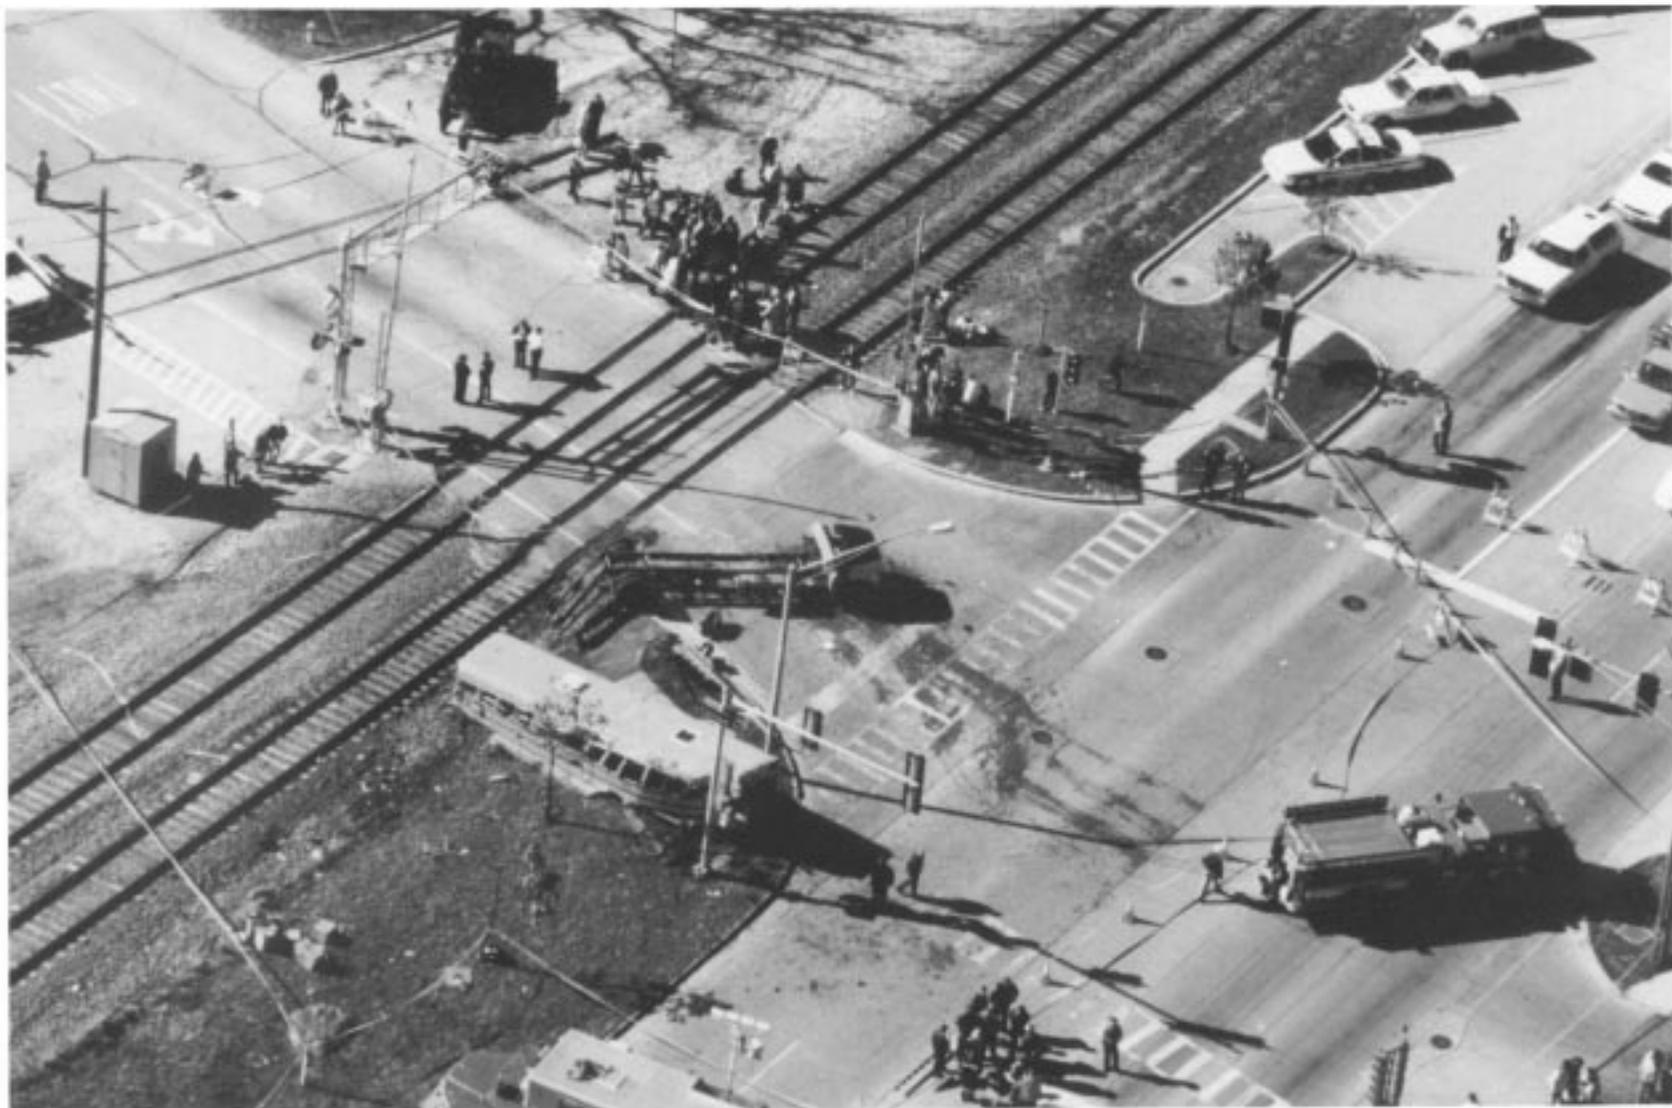
Figure 2 — Accident scene

An estimated 90 fire and emergency response personnel and the McHenry County Coroner's Office responded and were directed by a paramedic triage officer to assist in the treatment and transportation of victims. Additionally, officers from 12 police departments responded and assisted with the accident investigation and traffic control. In less than 90 minutes from the time the collision occurred, all seriously injured passengers had been transported to one of seven nearby hospitals. Table 1 lists the injuries reported in this accident.

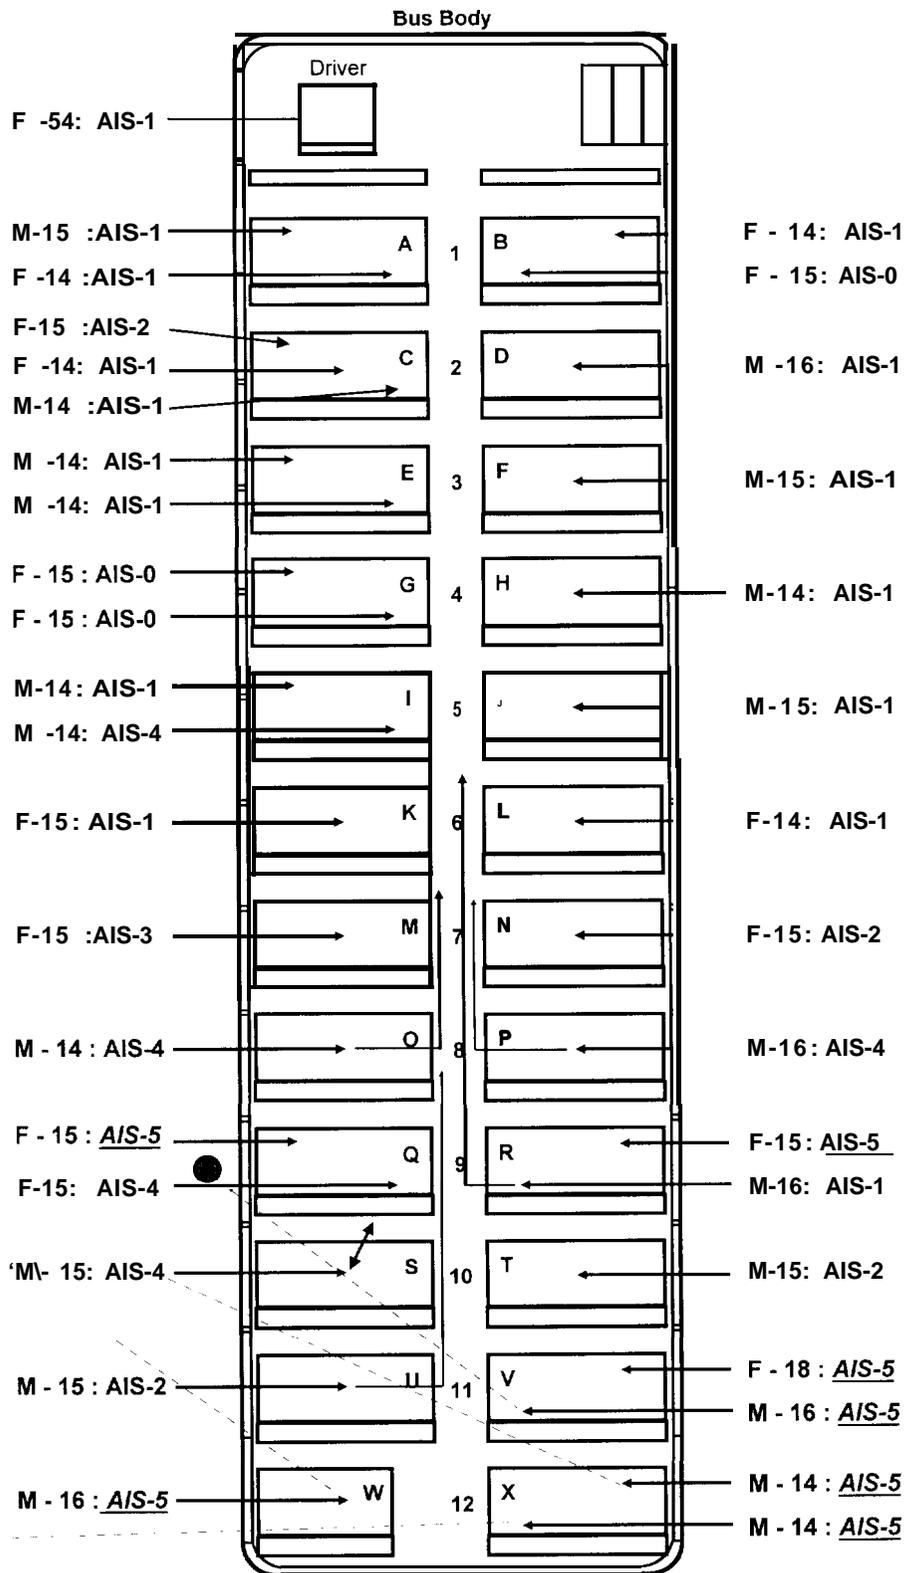
Figure 3 — School bus occupant seating and injury distribution diagram

According to witness statements, five passengers seated in rows 8 through 11 stood up before the collision. One passenger was standing at his seat in row 10 when the collision occurred. The other four had reportedly moved into the aisle and were attempting to move forward in the bus. They were found in the aisle near rows 6 and 7 after the accident. Four of the five passengers who stood sustained moderate to severe injuries and one passenger sustained minor injuries.

The minor to moderately injured passengers, who were seated primarily in rows 1 through 8, sustained concussions, contusions, lacerations, abrasions, and fractures of the head and extremities. The severely injured passenger in row 5 sustained lung contusions, a skull fracture, and a brain injury. The seriously injured passenger in row 7 sustained a concussion, a skull fracture, and a contusion of his

spleen. The severely injured passengers seated in rows 8, 9, and 10 sustained multiple contusions, lacerations, and fractures of the head, shoulders, and extremities, and blunt trauma to the internal organs, such as the lungs, spleen, kidneys, and liver.

The fatally injured passengers, who were seated in rows 9, 11, and 12, sustained multiple fractures to the head and pelvis, and contusions and lacerations to the internal organs, such as the pancreas, liver, kidneys, spleen, and lungs. All seven of the fatally injured passengers sustained severe skull fractures (some with facial bone fractures) with subsequent massive brain injuries. A circular 0.2- to 0.5-inch abrasion was noted on the forehead of one fatally injured passenger and another had a 1.2- by 2-inch L-shaped abrasion on the left side of the head. The interior window frames and the perforated sound panels inside the school bus were shaped similarly to these abrasions.

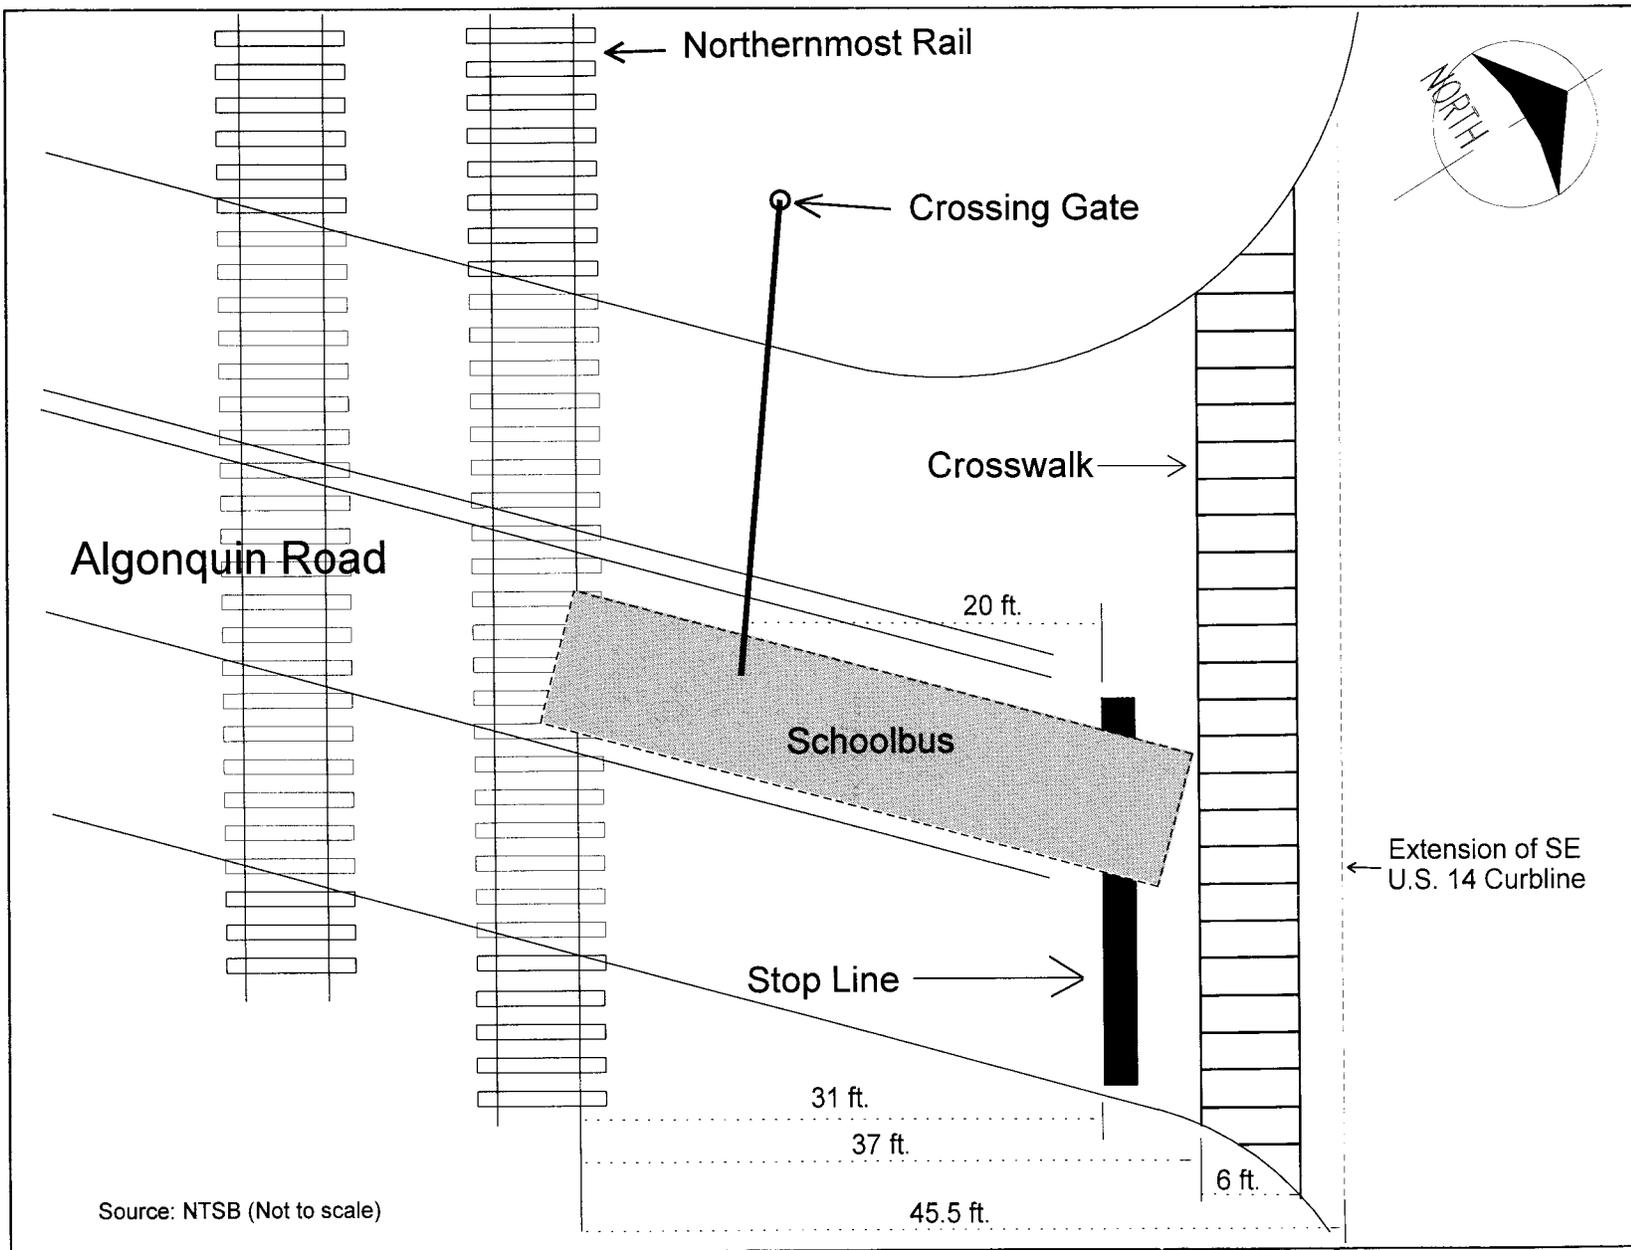
Figure 5 — Diagram of queuing area

feet long. In 1989, IDOT widened US 14 using about 35 feet of railroad property, thereby shortening this area to about 45 feet. In addition, IDOT widened the Algonquin Road approach to the intersection from a two-lane to a three-lane roadway, adding a left turn lane for northbound traffic.

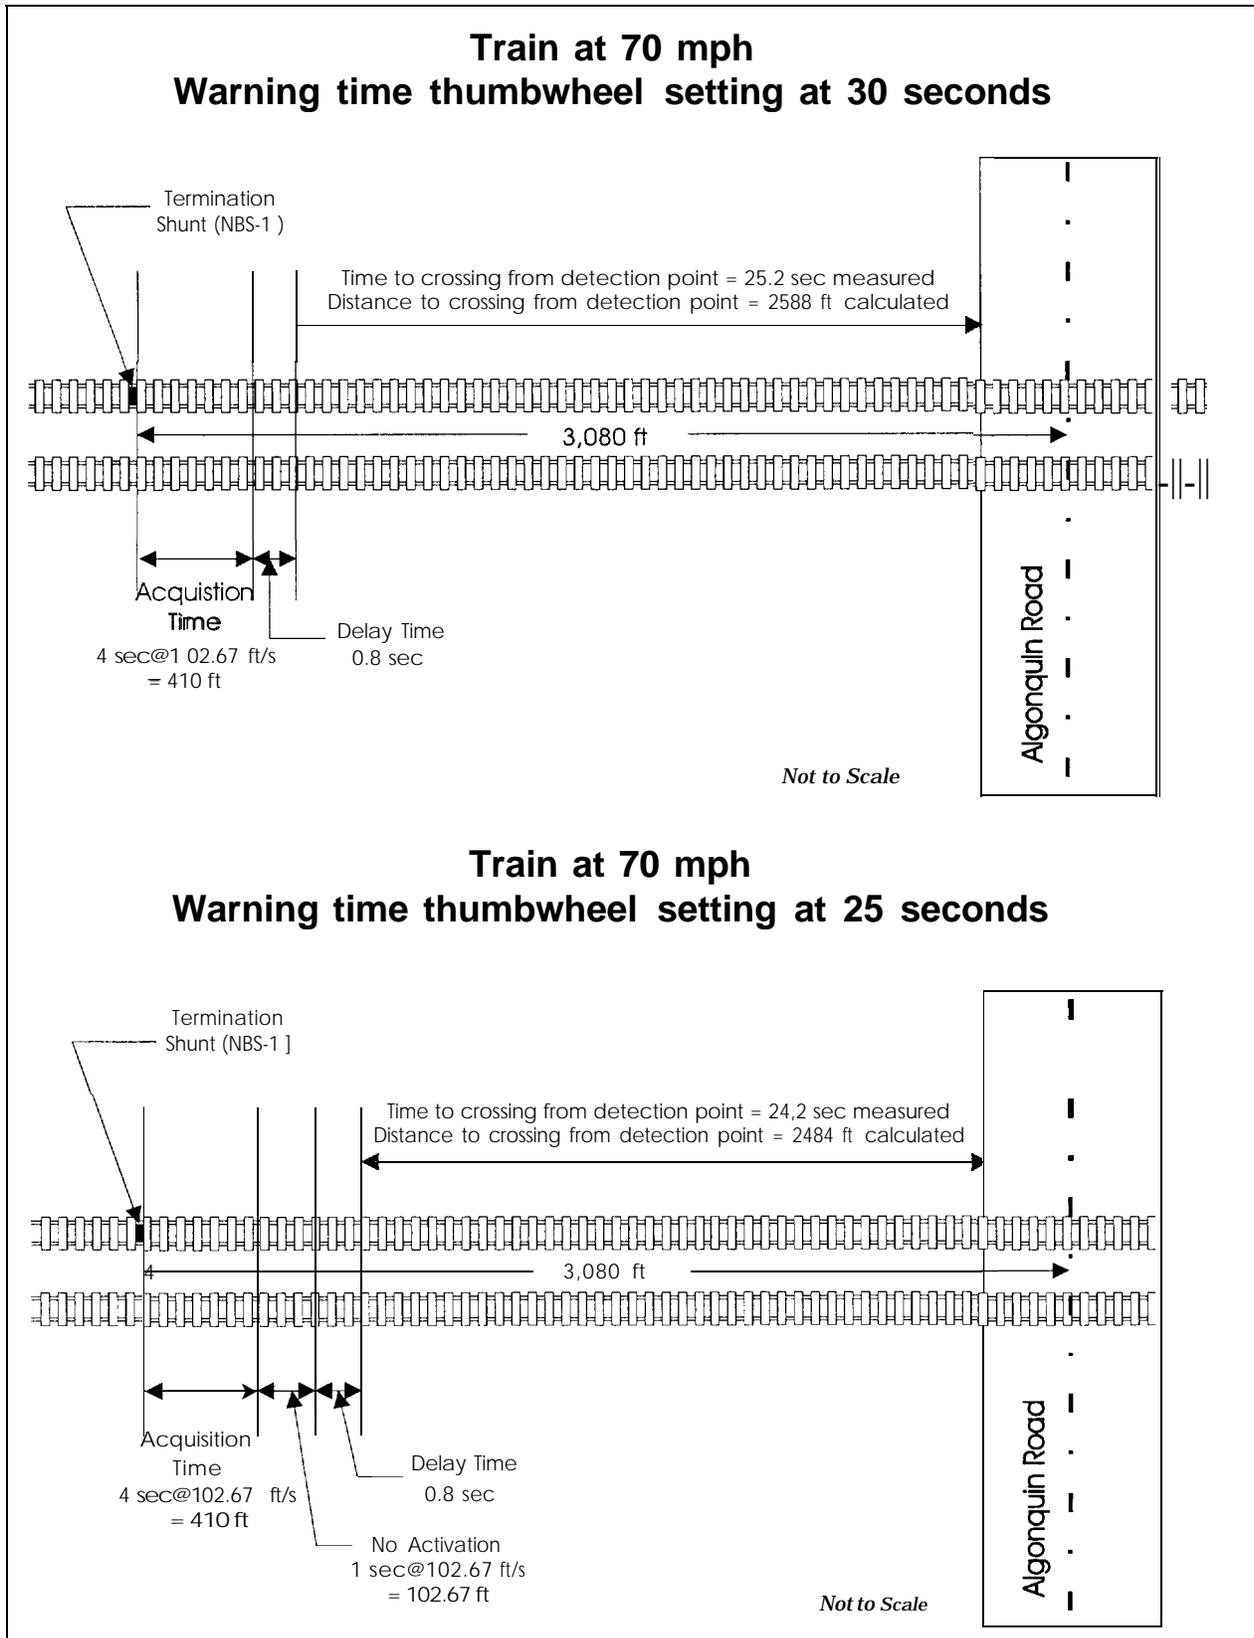
Figure 6 – Warning times for train at 70 mph

¹⁸ A lag time of about 8/10 second elapses before the grade crossing signal is activated, meaning a thumbwheel setting of 30 seconds at 3,080 feet produces 25 seconds rather than 26 seconds of railroad signal operation. A thumbwheel setting of 25 seconds actually produces 24 seconds. (See Tests and Research Section.)
