HIGHWAY/RAILROAD ACCIDENT REPORT

**Collision of Northeast Illinois Regional Commuter
Railroad Corporation (METRA) Train and
Transportation Joint Agreement School District 47/155
School Bus at Railroad/Highway Grade Crossing
in Fox River Grove, Illinois, on October 25, 1995**

NTSB/HAR-96/02 (PB96-916202)

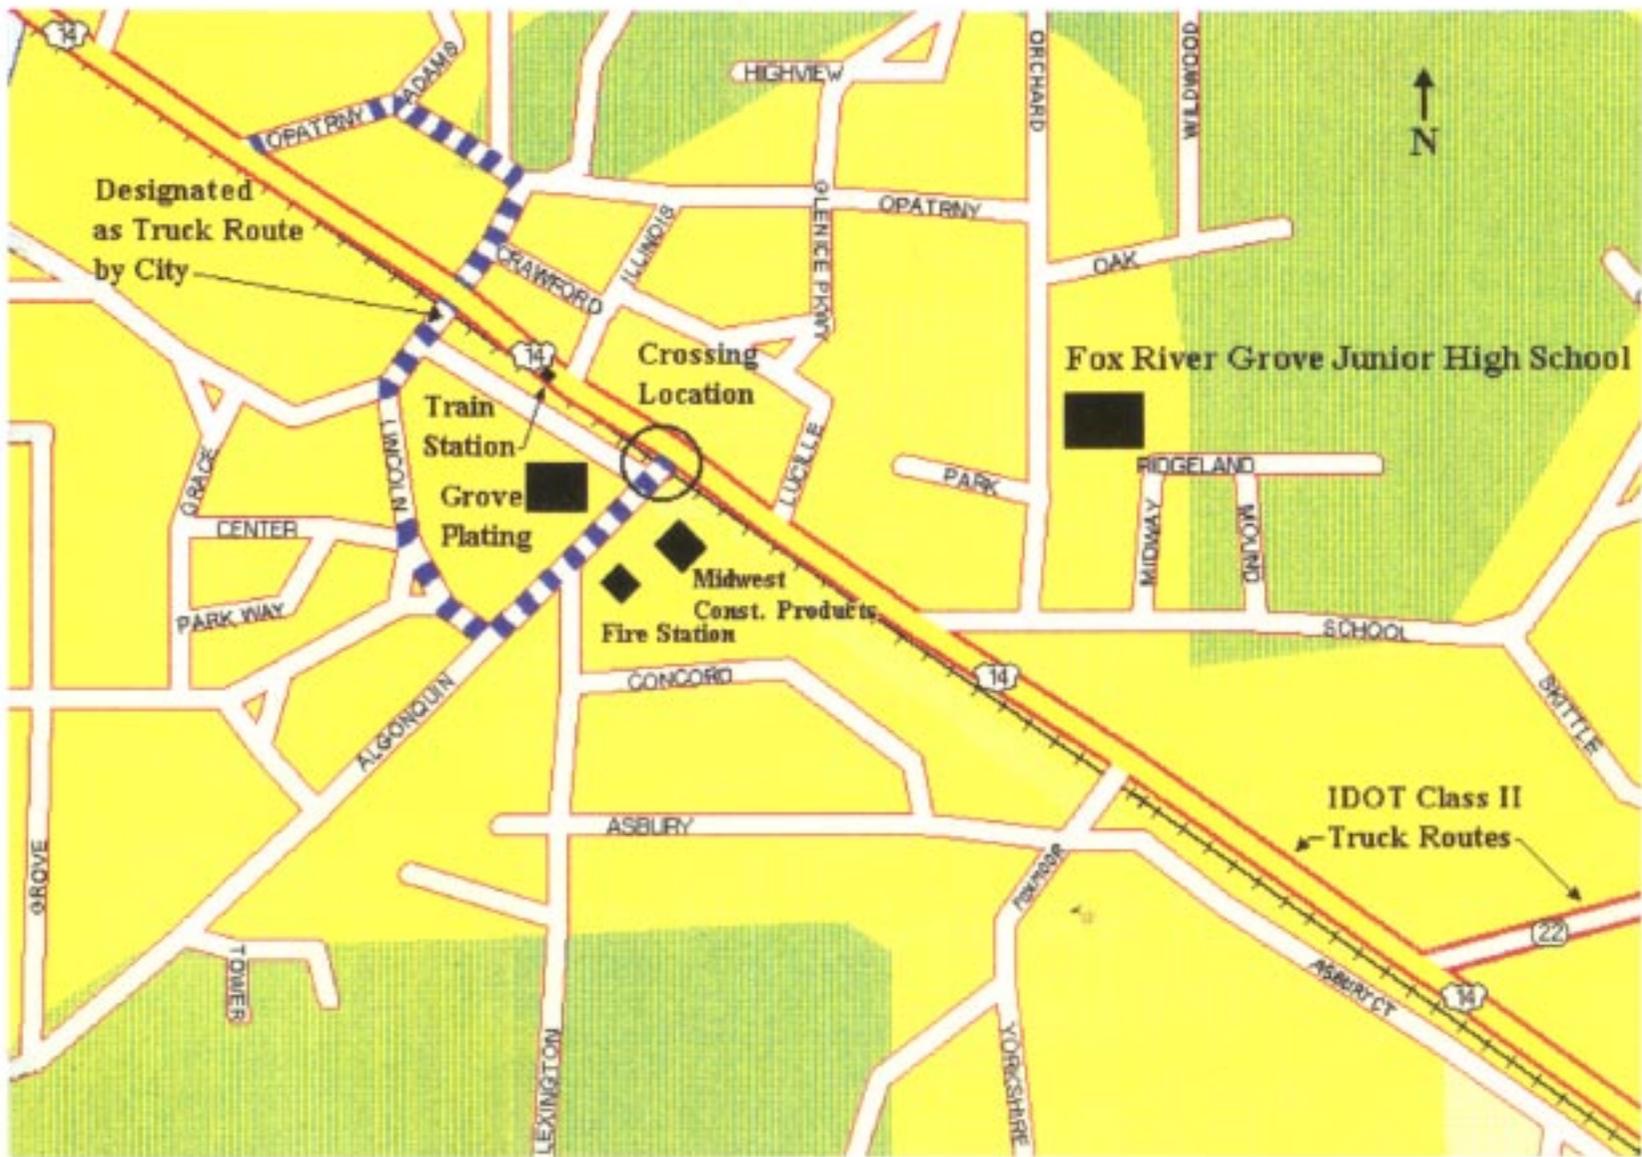
Figure 1 — Map of accident showing route of bus (dotted line).

About 7:10 a.m. on October 25, 1995, an eastbound Northeast Illinois Regional Commuter Railroad Corporation d/b/a Metropolitan Rail (METRA) express commuter train 624 en route to Chicago, Illinois, collided with the left rear side of a Transportation Joint Agreement (TJA) School District 47/155 school bus at a railroad/highway grade crossing in Fox River Grove, Illinois. (See figure 1.) The collision occurred on Algonquin Road near its intersection with U.S. Route 14 (US 14). The school busdriver had driven across the railroad tracks and stopped for the red indication of a highway traffic signal. The northbound school bus, which was waiting within the available storage space (queuing area), had its left rear extending about 3 feet into the path of the train.

A traffic signal system controls the intersection at Algonquin Road and US 14. Two railroad tracks cross Algonquin Road about 45 feet south of US 14. The railroad/highway grade crossing is equipped with active crossing warning devices (gates, lights, and bell). Loop detectors,² designed to detect the presence of vehicles, are embedded in the pavement on the north and south sides of the tracks.

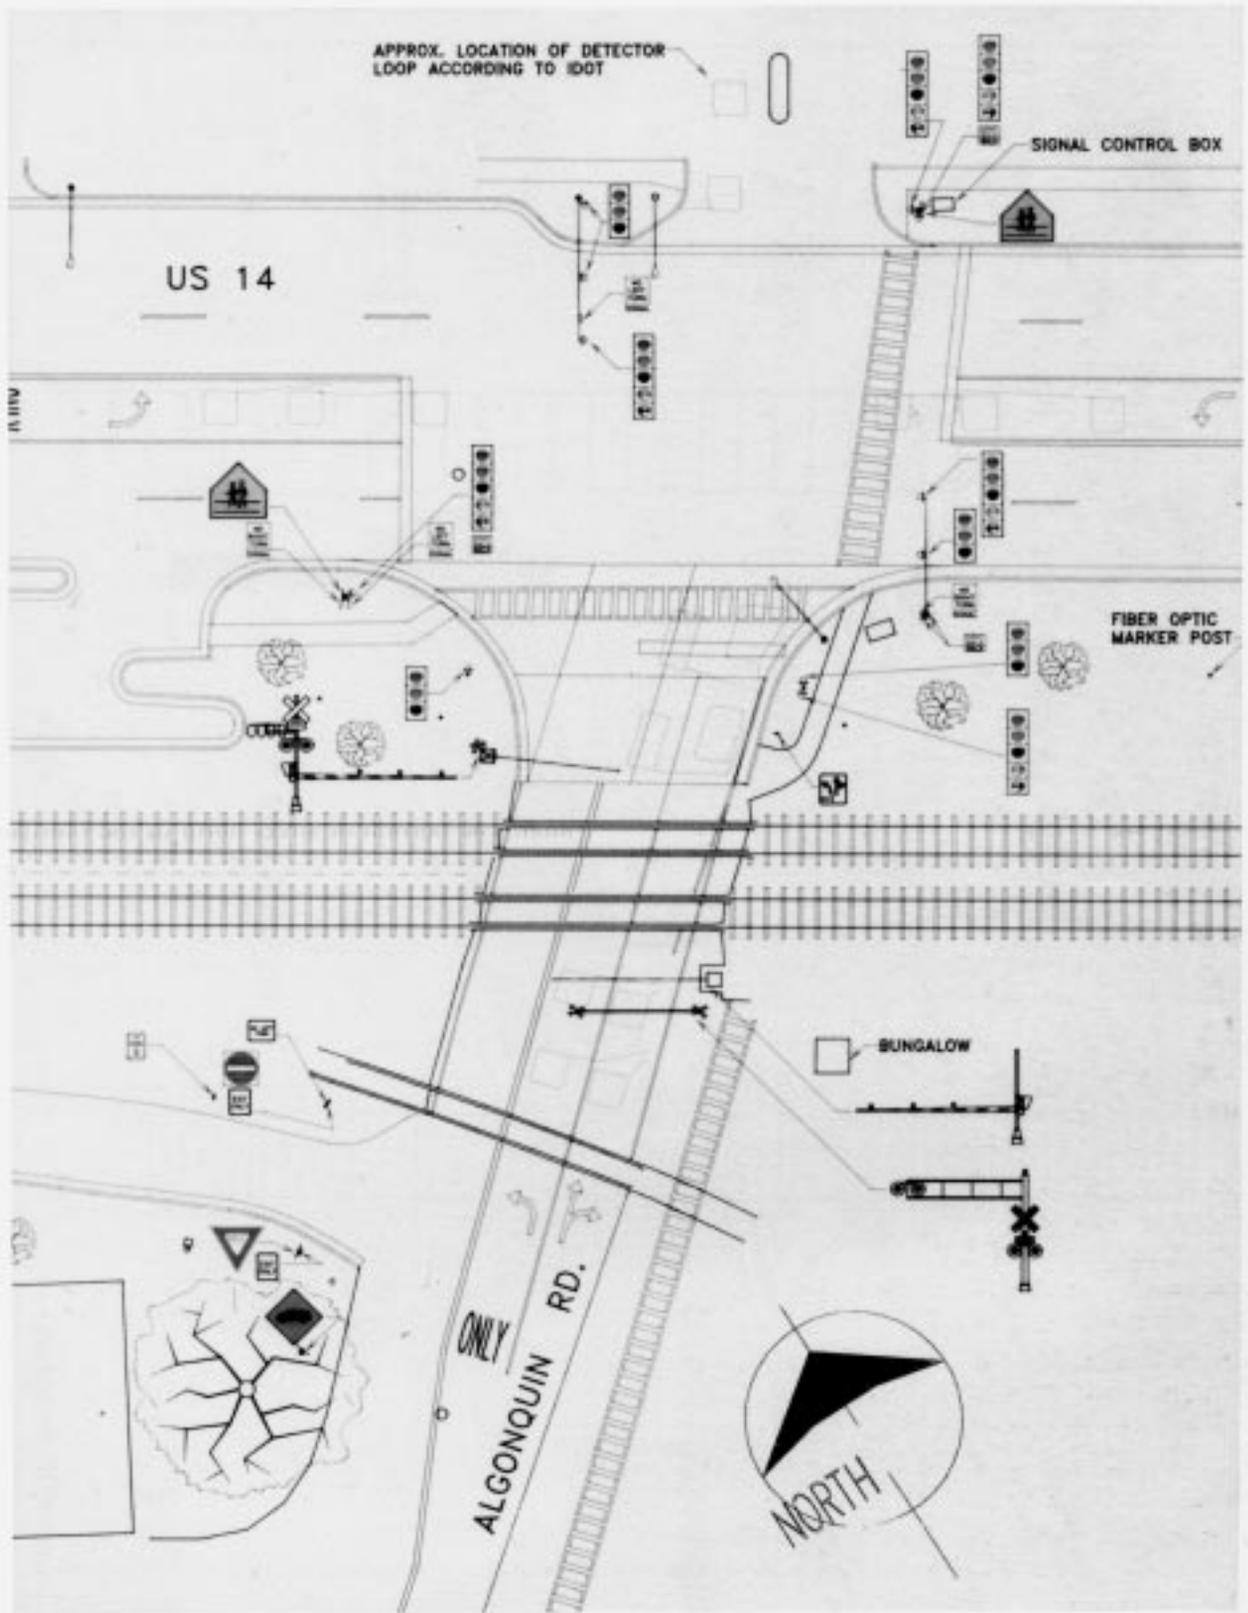
Figure 4 — Diagram of accident site (Courtesy of Safety Engineering Associates, Inc.)

Algonquin Road intersects the railroad tracks and US 14 at a 75-degree angle. Eighty feet south of the grade crossing, the northbound approach is a 2.5 percent upgrade that transitions to a 7.7 percent upgrade leading up to the grade crossing. Between the railroad tracks and US 14, the roadway slopes down 7.8 percent. The roadway is level 9 feet north of and 3 feet south of the outer rails. (See figures 4 and 5.)
